# Rectification of Captain Cook Bridge Bearings

**Abstract:** Captain Cook Bridge is an iconic bridge crossing the Brisbane River, and is the most trafficked bridge in Queensland, connecting the City's south with the Brisbane Central Business District (CBD).

The suspended spans are supported on sliding knuckle bearings at one end. The original DU Glacier and stainless steel sliding plates, failed and were replaced in 1996-97, with a glass filled PTFE sheet for the sliding material. After 20 years of service, routine inspections in July 2016, identified the extrusion of the PTFE sheet from the bearings on the southern suspended spans. The Department of Transport and Main Roads (TMR), developed unique rectification procedures that were implemented by early February 2017.

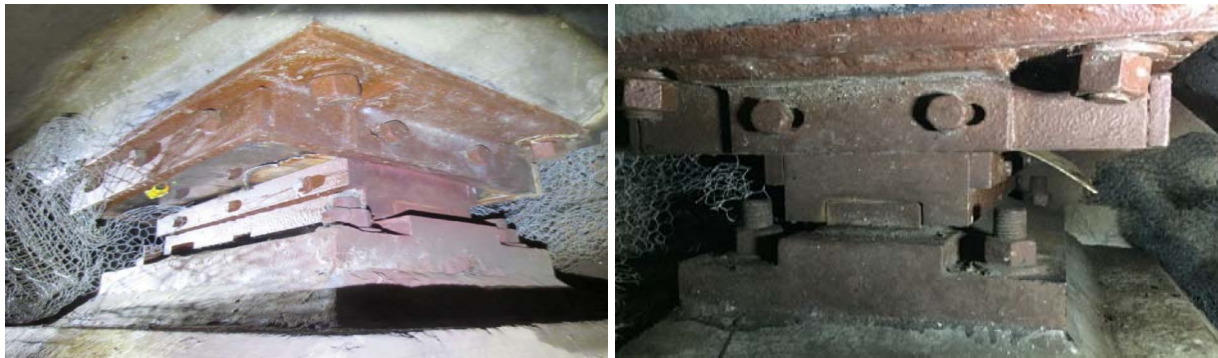
**Figure 2: Extrusion of the PTFE Sheeting from the Previous Sliding Bearings**

filled polytetrafluoroethylene (PTFE) sliding material in 1996-97 (2). Routine inspections in July 2016, revealed the extrusion of the PTFE sheeting from the sliding bearings of the southern suspended spans, after 20 years of service (Figure 2).

The glass filled PTFE sliding material was found to be extruding from the sliding bearings of the southern suspended spans (Figure 2 and 4). There was no extrusion identified on the sliding bearings of the northern suspended spans. The measured extrusion ranged between 60-85mm, and was protruding from the southern corners.

- Non-uniform bearing and asymmetrical compressive loading resulting in uneven creep and deformation of the PTFE material, commonly referred to as ratcheting (3).
- Transverse flexure of the concrete diaphragm resulting in non-uniform and concentrated loading.
- Yielding and deformation of base-plate fulcrum restricting rotation of the knuckle leading to non-uniform loading on the PTFE.
- Increased traffic loads increasing the pressure on the PTFE.
